Piscataquog River Stream Crossing Assessment Project Final Report: Evaluating Aquatic Organism Passage (AOP)

Trout Unlimited, Concord, NH

Southern New Hampshire Planning Commission

December 2012

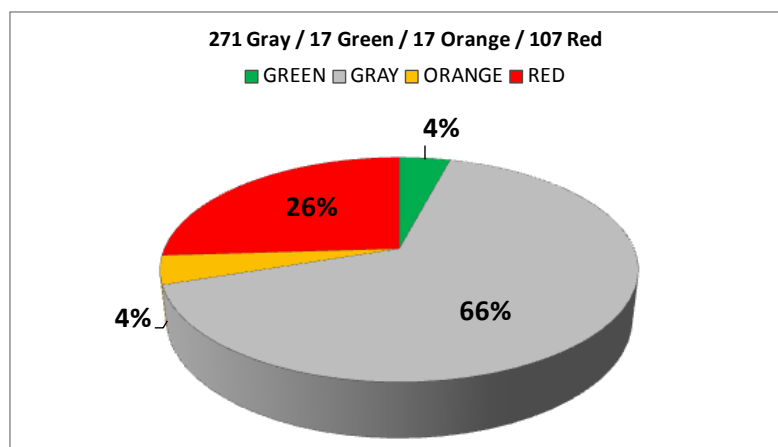
Figure 2
AOP status of all assessed crossings

The resulting dataset of 412 crossings was used for the AOP analysis (see Figure 2). Of the 412 sites assessed:

- **66 percent** of crossings surveyed represented reduced connectivity for fish passage depending on flow conditions and life stage;
- **26 percent** were determined to be complete barriers to AOP;
- **4 percent** were considered barriers for all but adult salmonids; and
- **4 percent** were completely passable by all species.

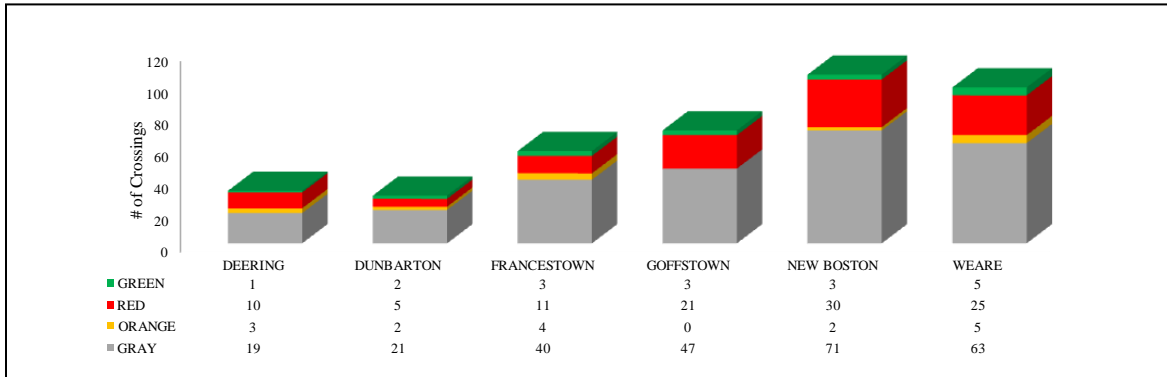
Figure 3
AOP status and number of crossings in the six major towns

Greater than 96 percent of all the stream crossings assessed are located in the following six towns identified in Figure 3: Deering, Dunbarton, Francestown, Goffstown, New Boston and Weare. Figure 3 provides a summary of these sites and includes the AOP score rating for each crossing.

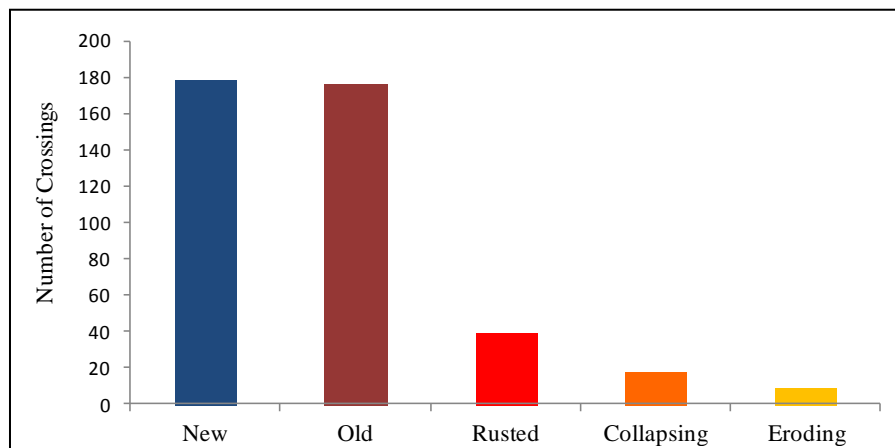
Figure 3
Condition of all road stream crossings

Overall, **43** percent of the stream crossings assessed are considered to be: **New** or in relatively good condition; **42** percent of the crossings were found to be in **Old** condition, with the remaining **15** percent falling into **rusted, collapsing or eroded** categories (see Figure 3).

Figure 3 illustrates that 43 percent of the crossings were considered to be New or in relatively good condition. This is slightly better than what has been observed in many other watershed assessments. Although the percent of "New" crossings would ideally be much higher, the reality is this is an expensive proposition to undertake and an excellent long-term goal for a community to work toward. The immediate and ongoing challenge for many Piscataquog River communities is the 42 percent of crossings found to be in Old condition, with the remaining 15 percent falling into rusted, collapsing or eroded categories. This failing infrastructure will present a significant financial

investment for communities over the next couple of decades. One suggestion is for communities to consider creating a restructuring / replacement schedule based on a combination of assessments and results consisting of this AOP assessment as well as a hydraulic and geomorphic assessment being completed over the next couple seasons.
